Maryland Historical Trust
State Historic Sites Inventory Form

Survey No. B-4380

historic 117-123 West Saratoga Street

7. Description

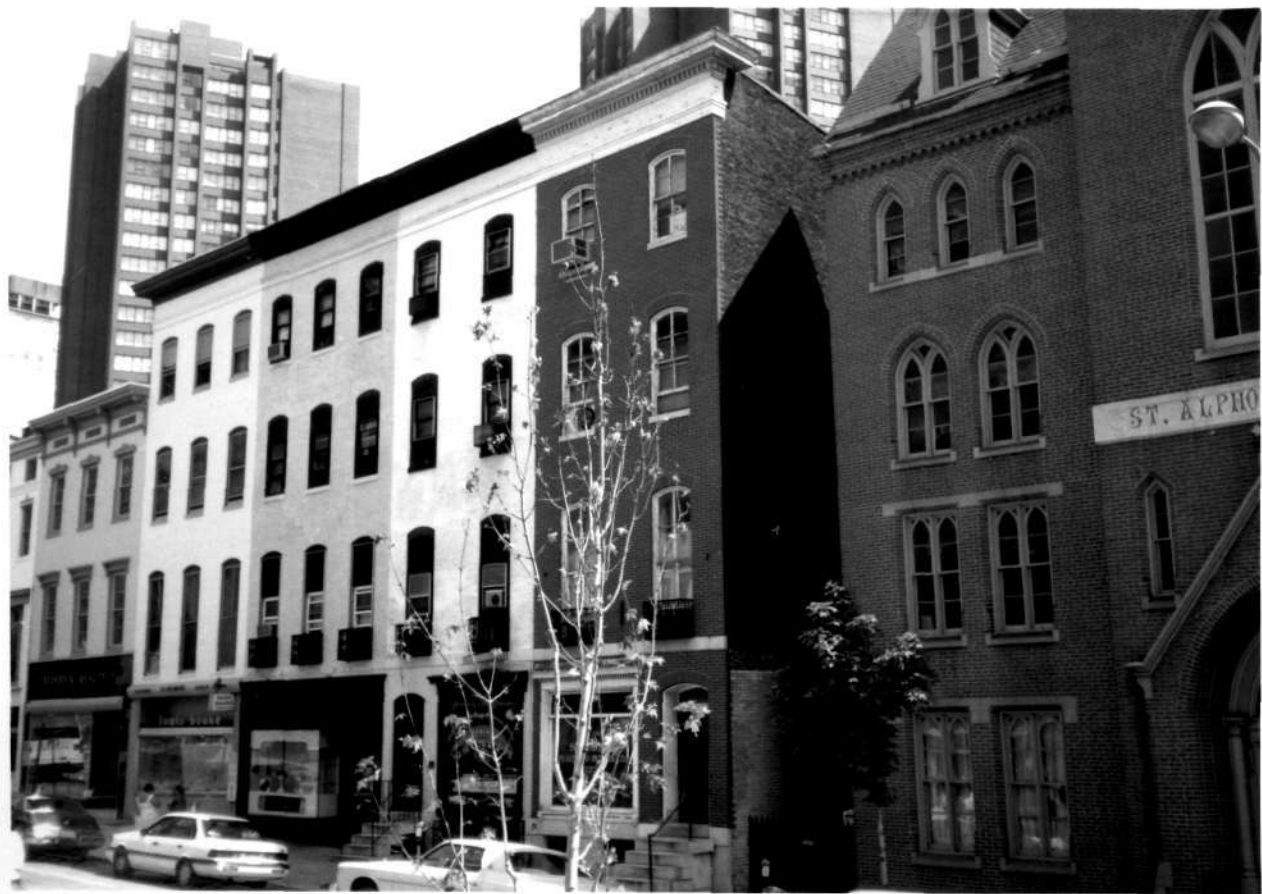
1/5

This circa 1860 commercial block is four stories tall and ten bays wide. It is divided into four store units. The first story facades are all different, but the upper stories are consistent. The stretcher bond, brick building abuts a partywall structure to the east and an alley to the west.

View of block, north elevation

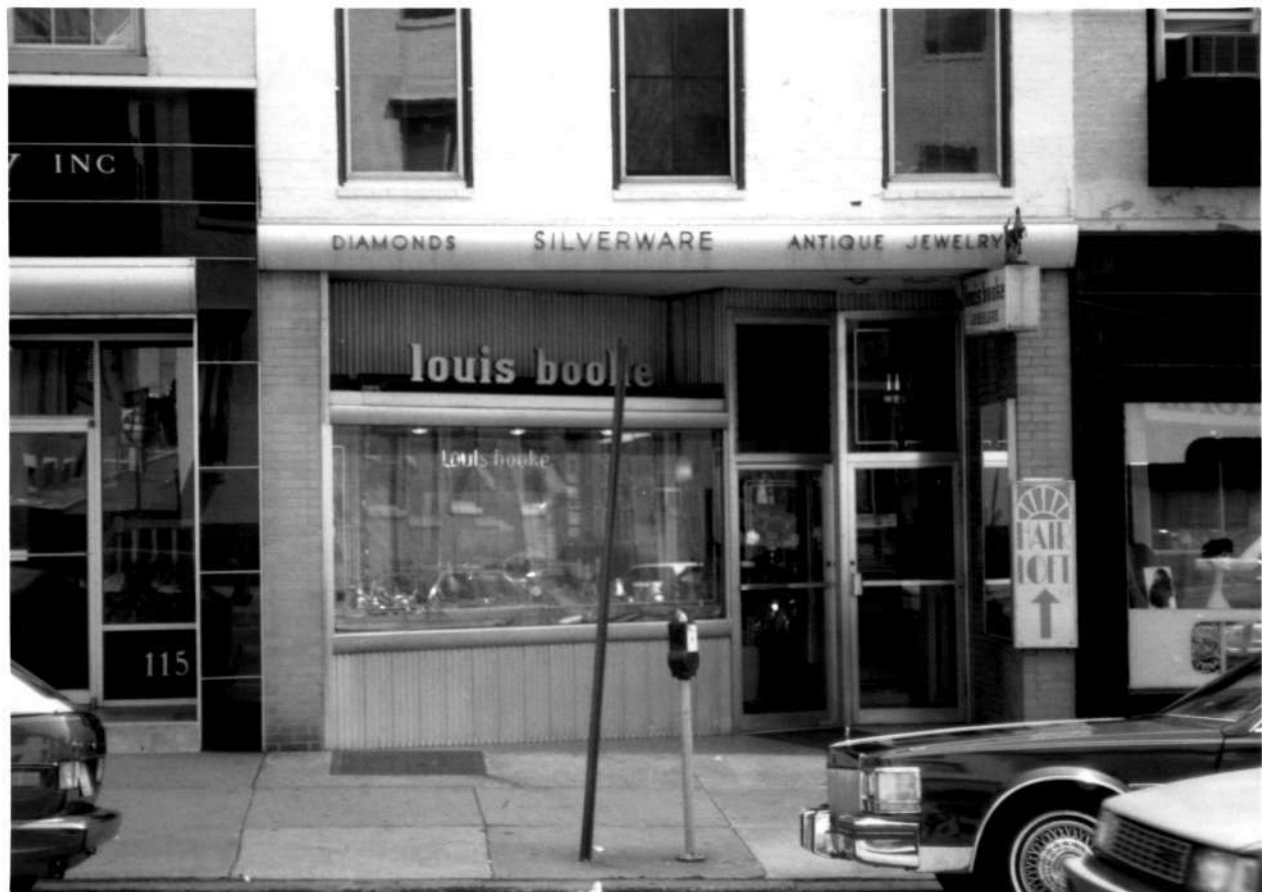
2/5

The first story of #117 has been altered in the 1940s-1950s. The wall is framed by yellow brick piers that flank an angled, recessed display window and entrance. The angled display window is positioned in the east. The display window does not run all the way to the ceiling, but is boxed in a glass case. The wall is recessed behind the display case. The space is filled with a standing sign with the name of the store. The entry to the first-story commercial space is also on the angle. A second door is set back parallel to the street. This is the door to the upper stories. Both glass doors have transoms above. The wall around the window and doors is sided in fluted aluminum siding. The vestibule is laid with brown tiles. The street frontage of the three-bay store is 19'.

Facade detail

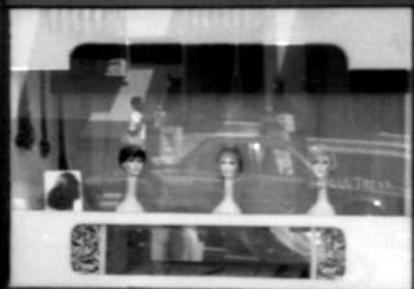
3/5

The first story of #119 has been altered in the 1950s. It consists of a display window to the east and an angled recessed entrance to the west. The display window is a single large plate set above a brick foundation wall. The vestibule is laid in white hexagonal tiles with a brown tile Greek key frieze. Wood pilasters with recessed panels support a broad entablature frame the storefront. The entablature has a cornice of raised molding. The street frontage of the three-bay store is 19'2".

Facade detail

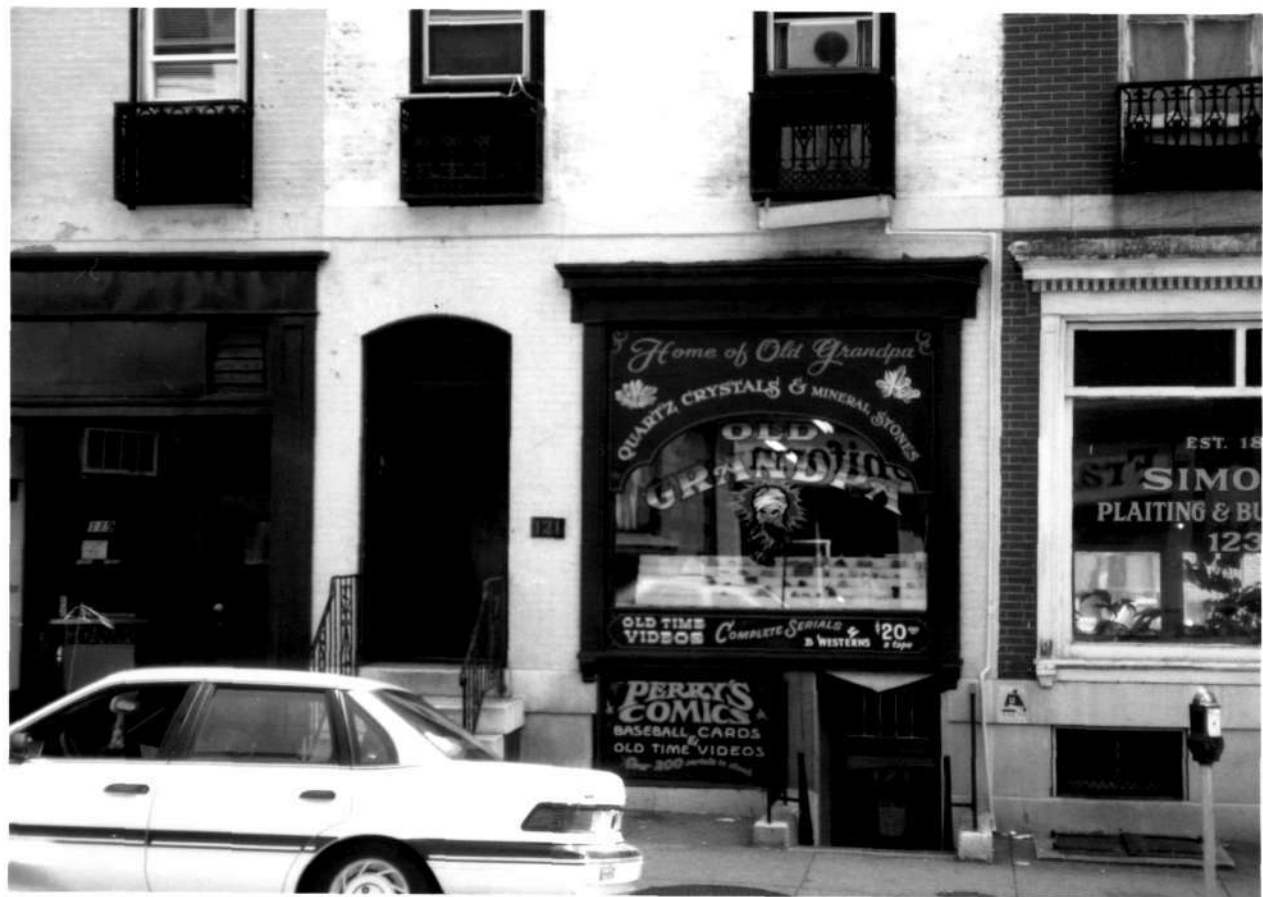
4/5

The first story of #121 consists of an entrance to the east and a display window to the west. Five marble steps lead to the entrance which is a rounded arch opening cut into the brick wall. A recessed vestibule lies behind the opening. The outer door is gone, but the transom remains. The vestibule has a door to the south that leads to the stair hall. The door to the west opens into the first-story store. The vestibule is panelled in mock wood panelling and has a modern tiled floor. The display window has 19th-century wood surrounds consisting of pilasters that support an entablature with raised molding along the bottom. The cellar window in the first bay is set into the stone foundation wall. A separate cellar entrance is in the second bay, reached by a flight of steps from the sidewalk. The street frontage of the two-bay store is 16'10".

Facade detail

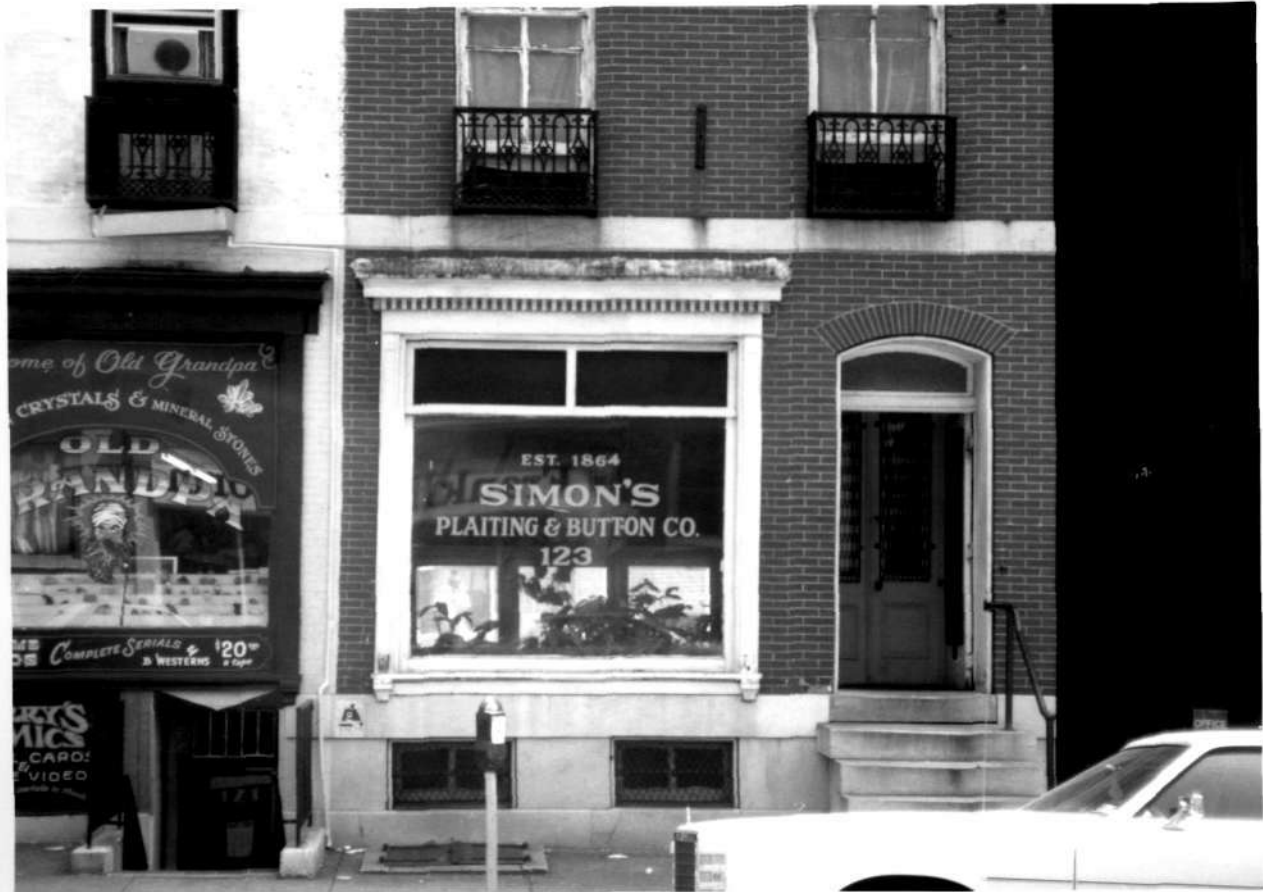
5/5

The first story of #123 contains a display window to the west and an entrance to the east. Six marble steps lead to the entrance which is a rounded arch opening cut into the brick wall. The outer door is glazed with wood surrounds and has a hinged transom.

A recessed vestibule floored with black and white tiles and wallpapered with Lincrusta. The vestibule two doors: a double Italianate panelled door with arched lights to the south and to the east a door with a glazed panel above and two raised panels below. Two cellar windows are cut into the stone foundation.

Facade Detail
